Special Investigation Report
Aircraft Separation Incidents at Hartsfield
Atlanta International Airport, Atlanta, Georgia
October 7, 1980

SPECIAL INVESTIGATION REPORT

**AIRCRAFT SEPARATION INCIDENTS
AT HARTSFIELD ATLANTA INTERNATIONAL AIRPORT
ATLANTA, GEORGIA
OCTOBER 7, 1980**

NTSB-SIR-81-6

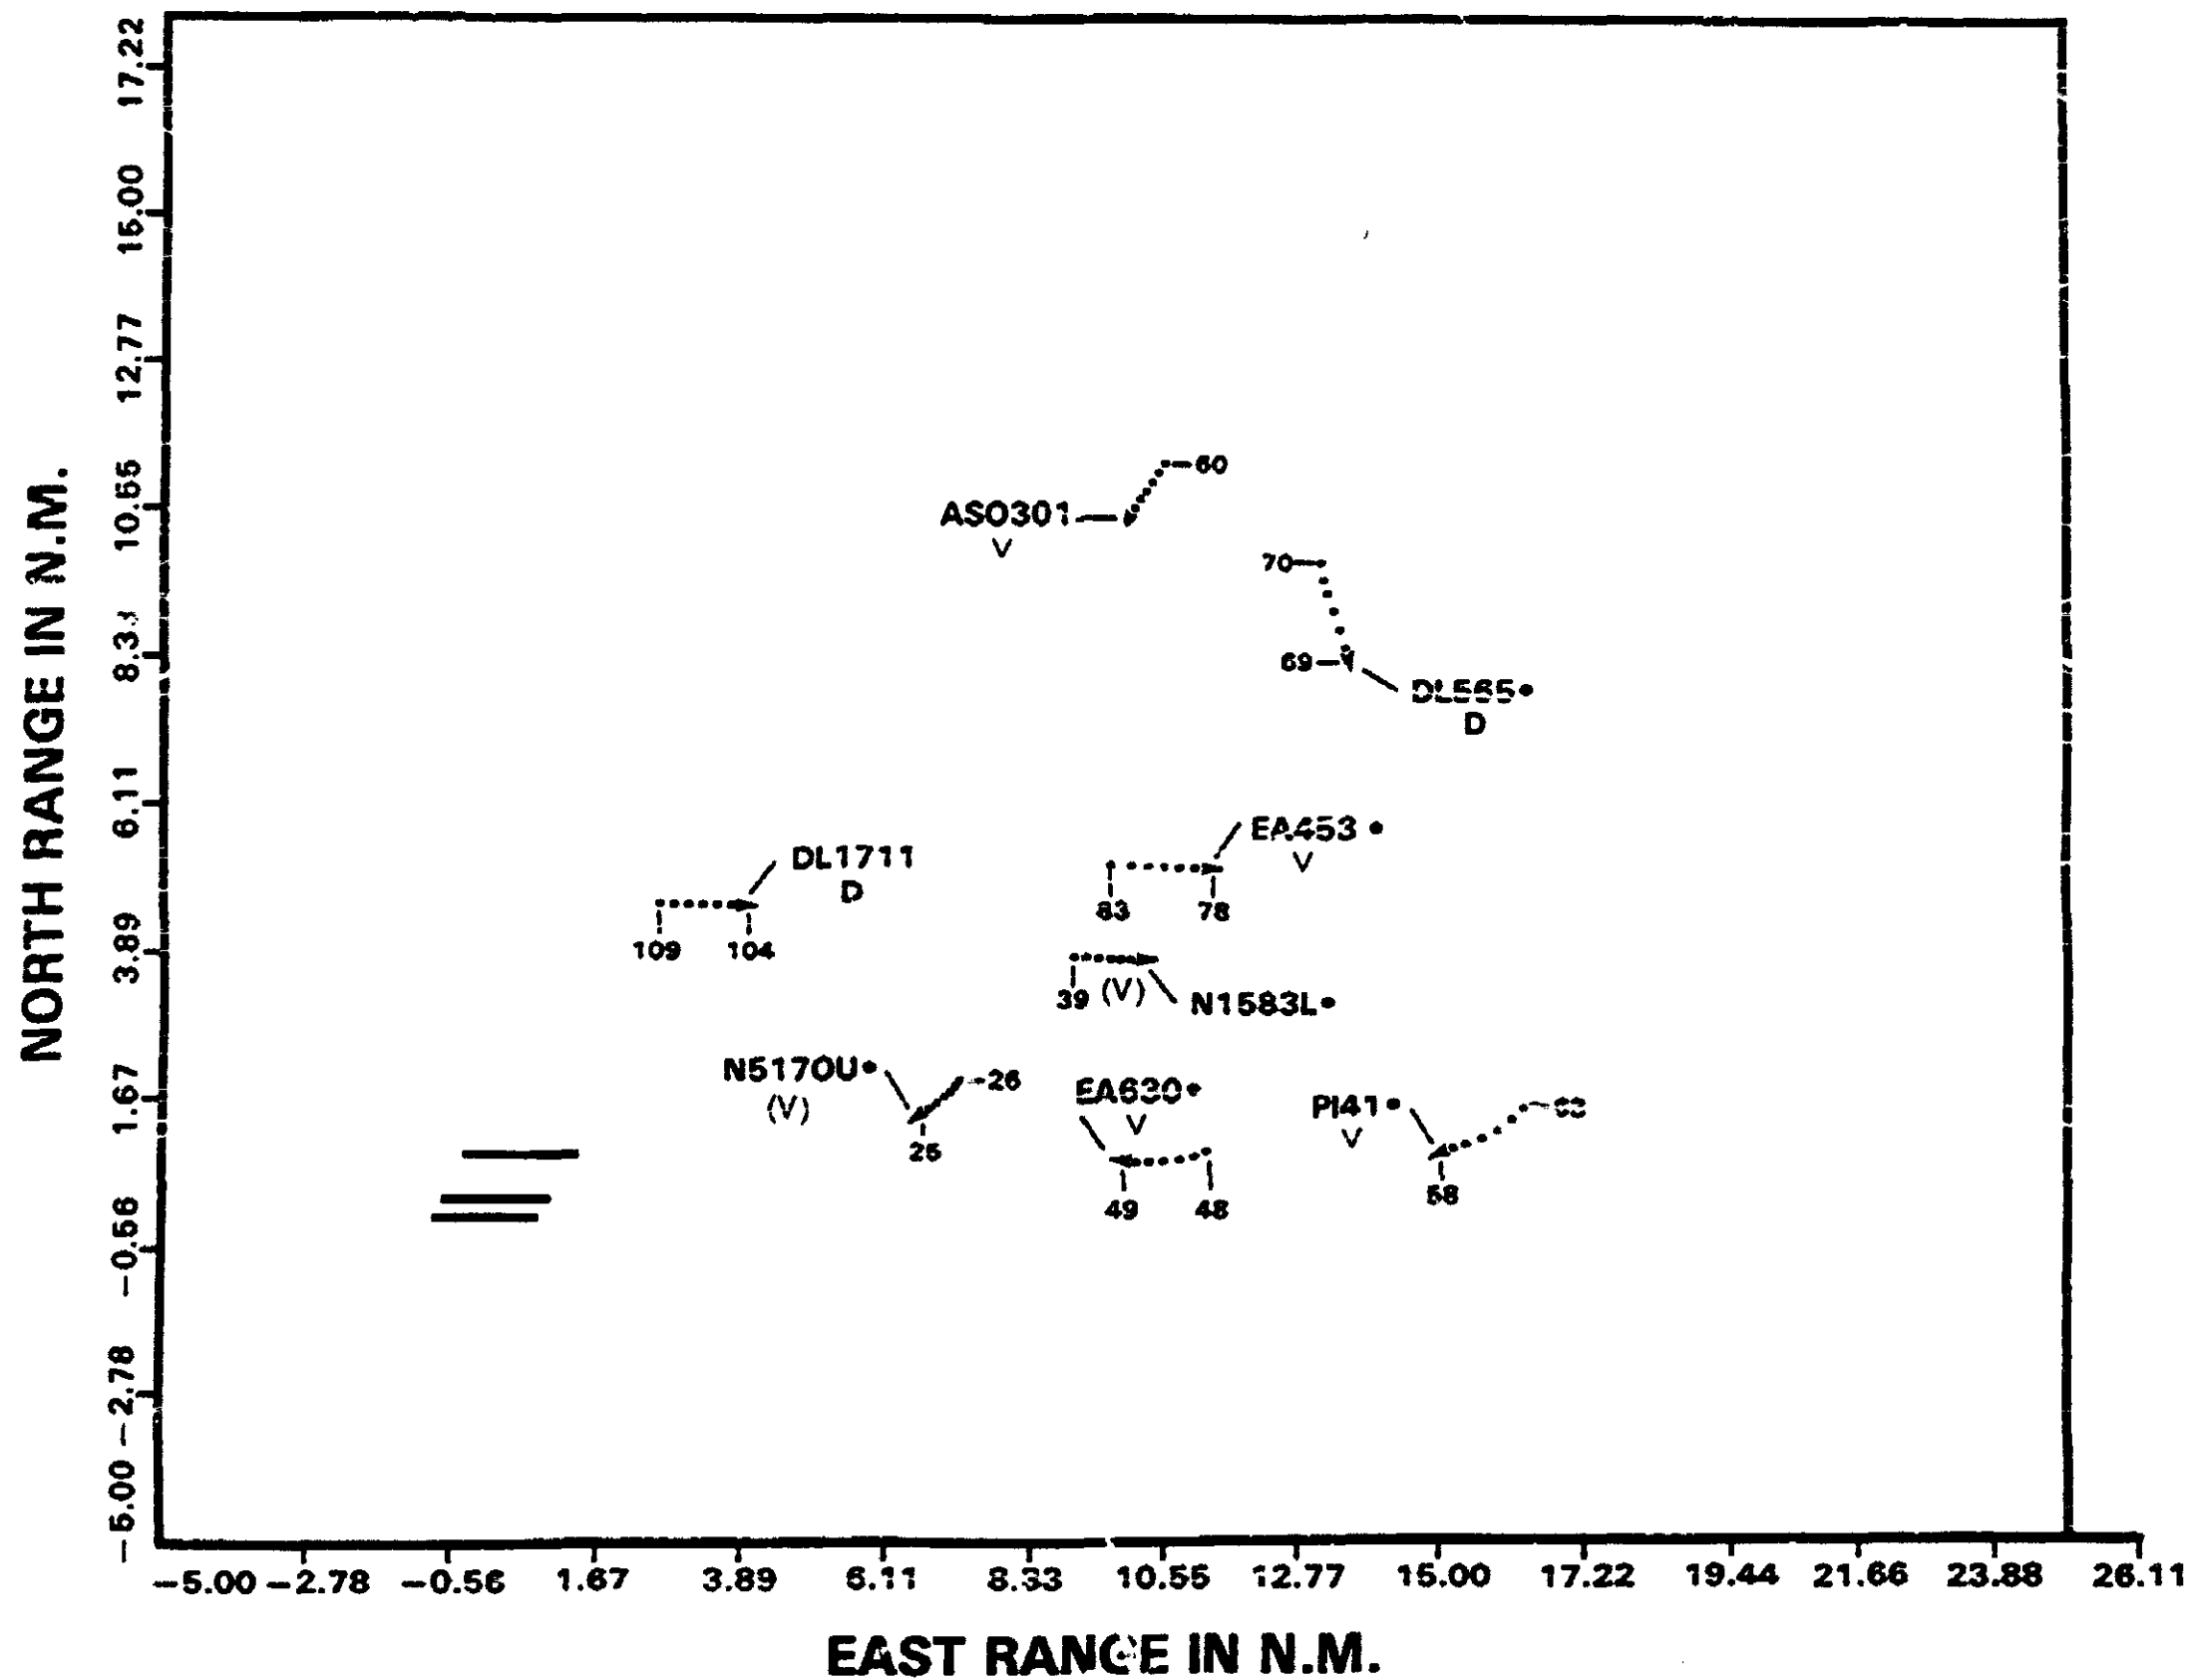
08:14:00.0-08:14:30.0

EA630's 0814:17 remark that they could have slowed is significant. During the time period covered in this investigation, the final controller never used the speed adjustment as part of his technique.

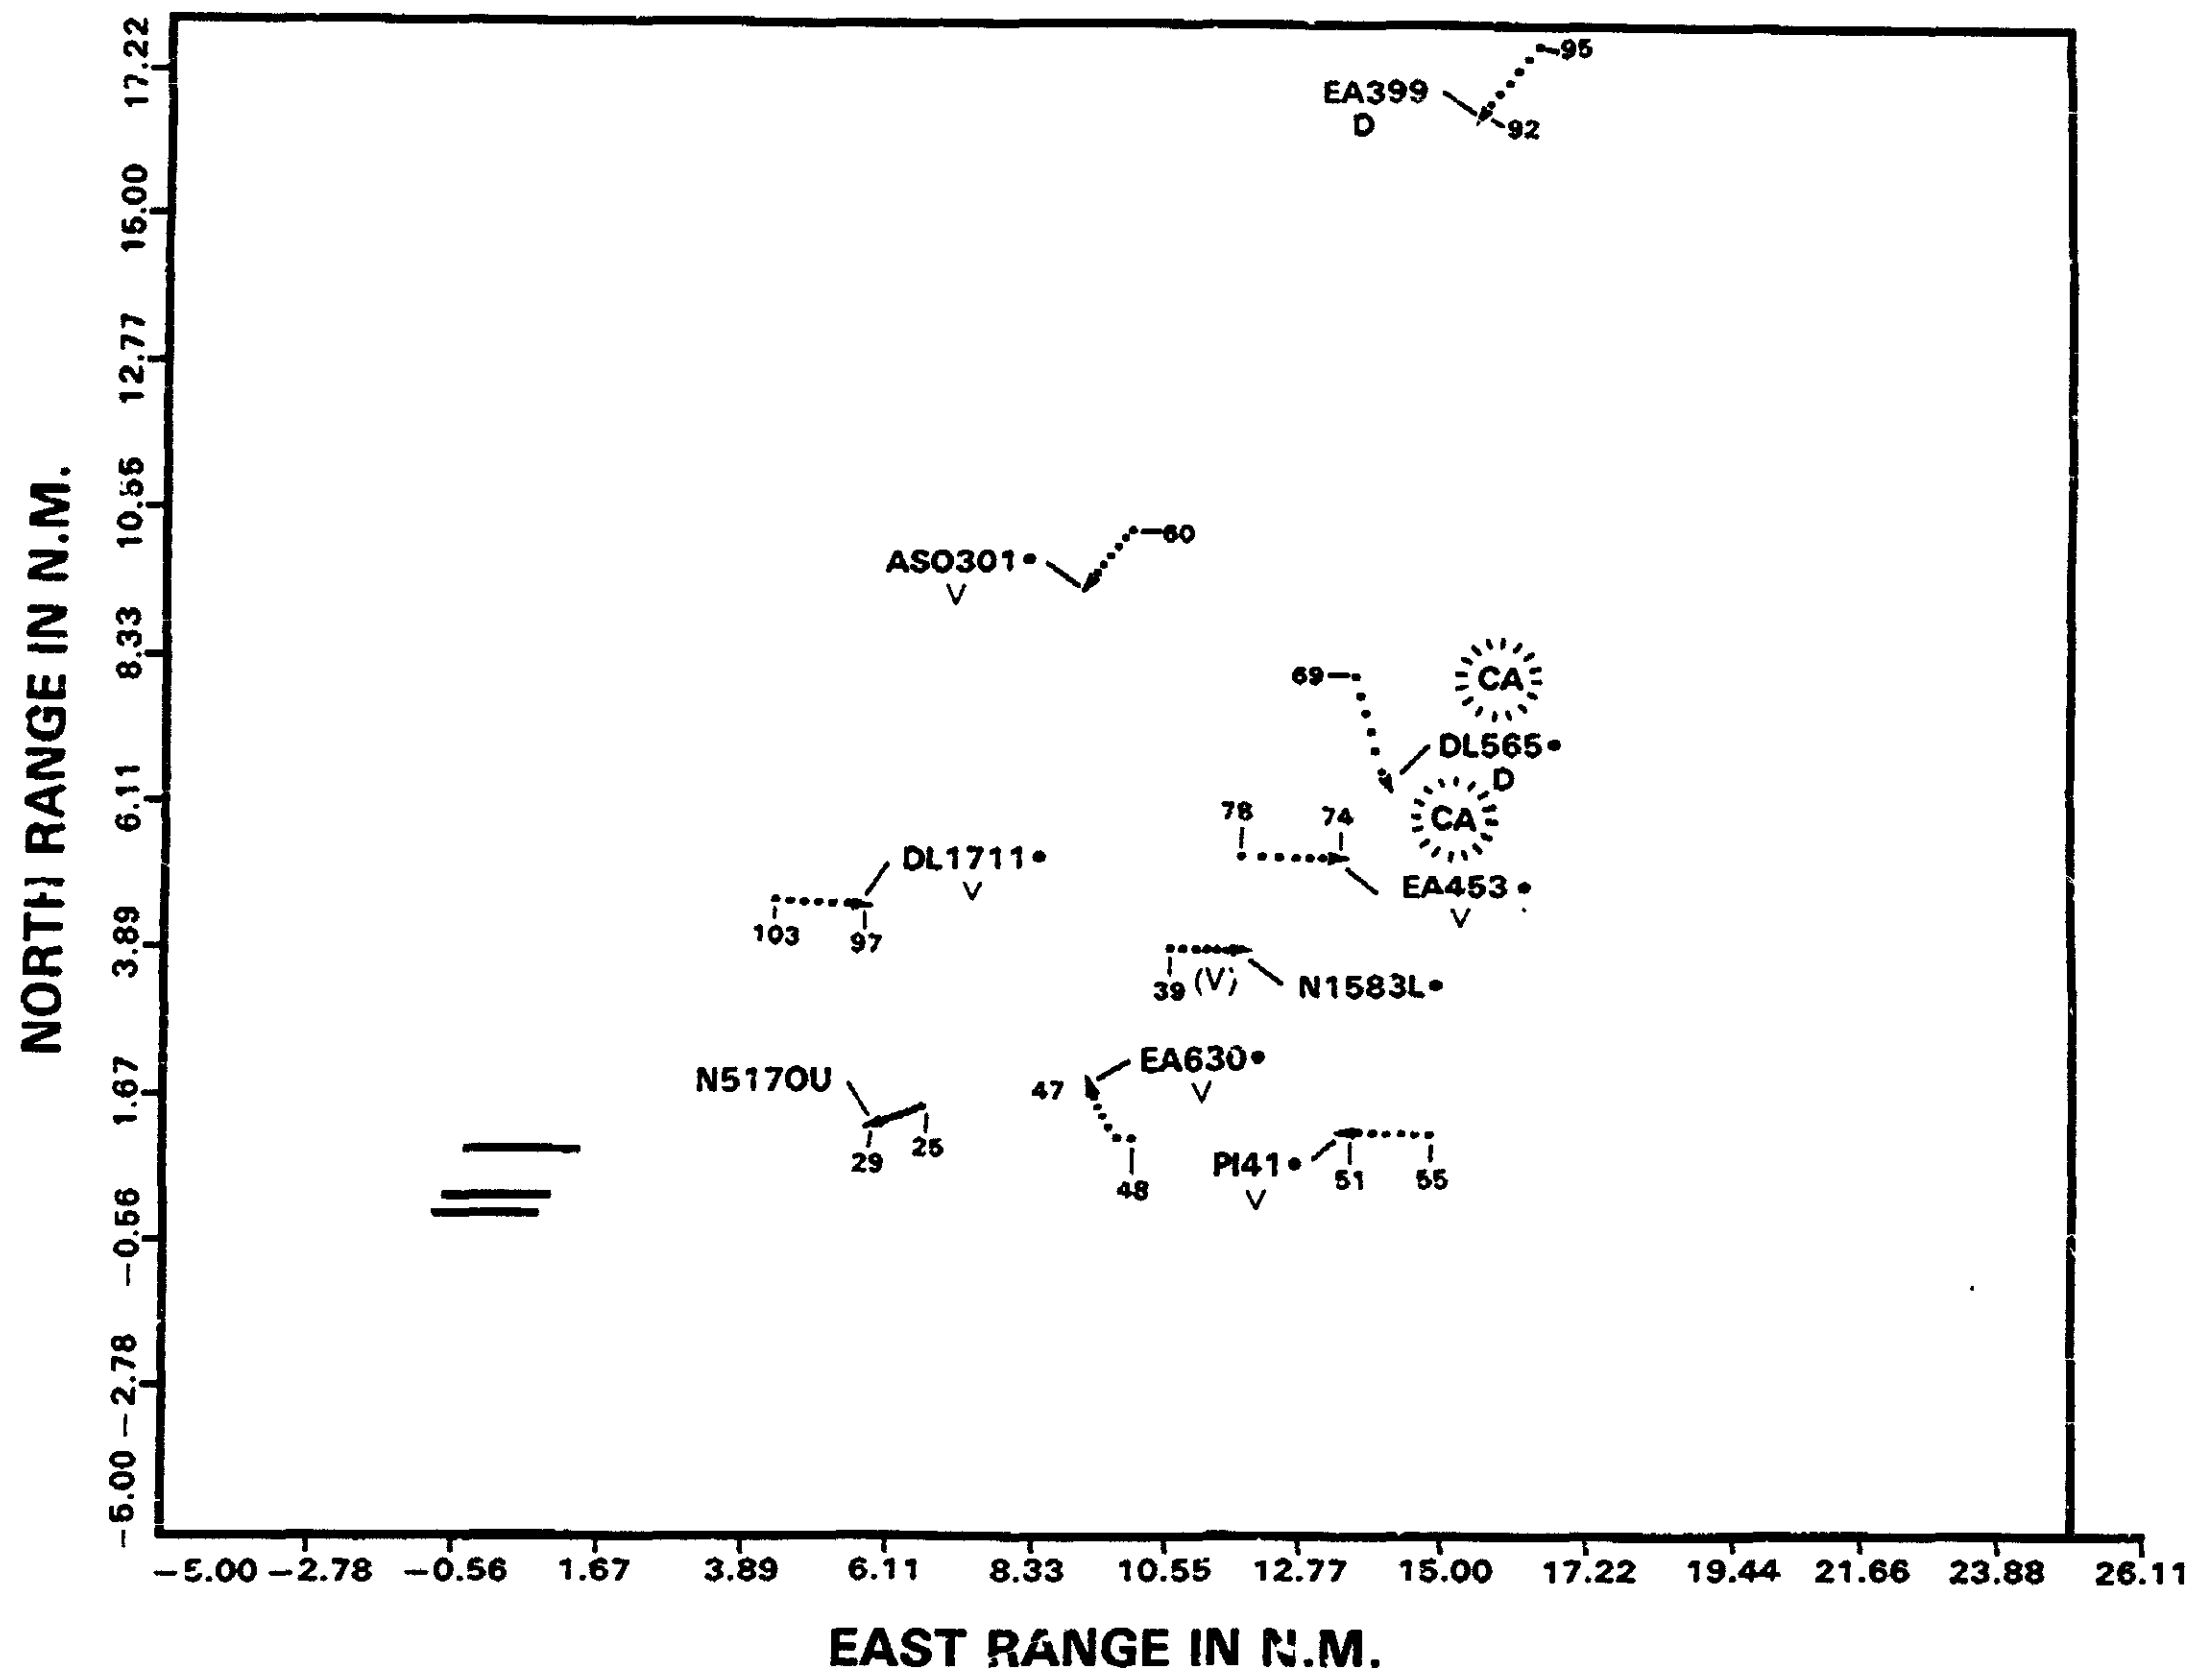
08:14:30.0-08:15:00.0

At 1437, the conflict alert activated for both DL565 and EA453. When the final controller asked DL565, "you with me," the controller would normally look at the target and associated data tag of the aircraft being addressed. When the final controller did this he should first have seen the presence of another aircraft and then looked to see the altitude of that other aircraft. Because the feeder controller still had electronic track control of the DL565 data tag, the conflict alert activated on both the controllers' scopes. However, for reasons to be discussed later in this report, both controllers missed the conflict alert. This does not explain why the final controller did not see EA453's altitude, and take the appropriate corrective action. It should be noted though, that the final controller stated that the data tags overlapped for EA453 and DL565. He also stated that he didn't know that DL565 was at 7,000 feet.

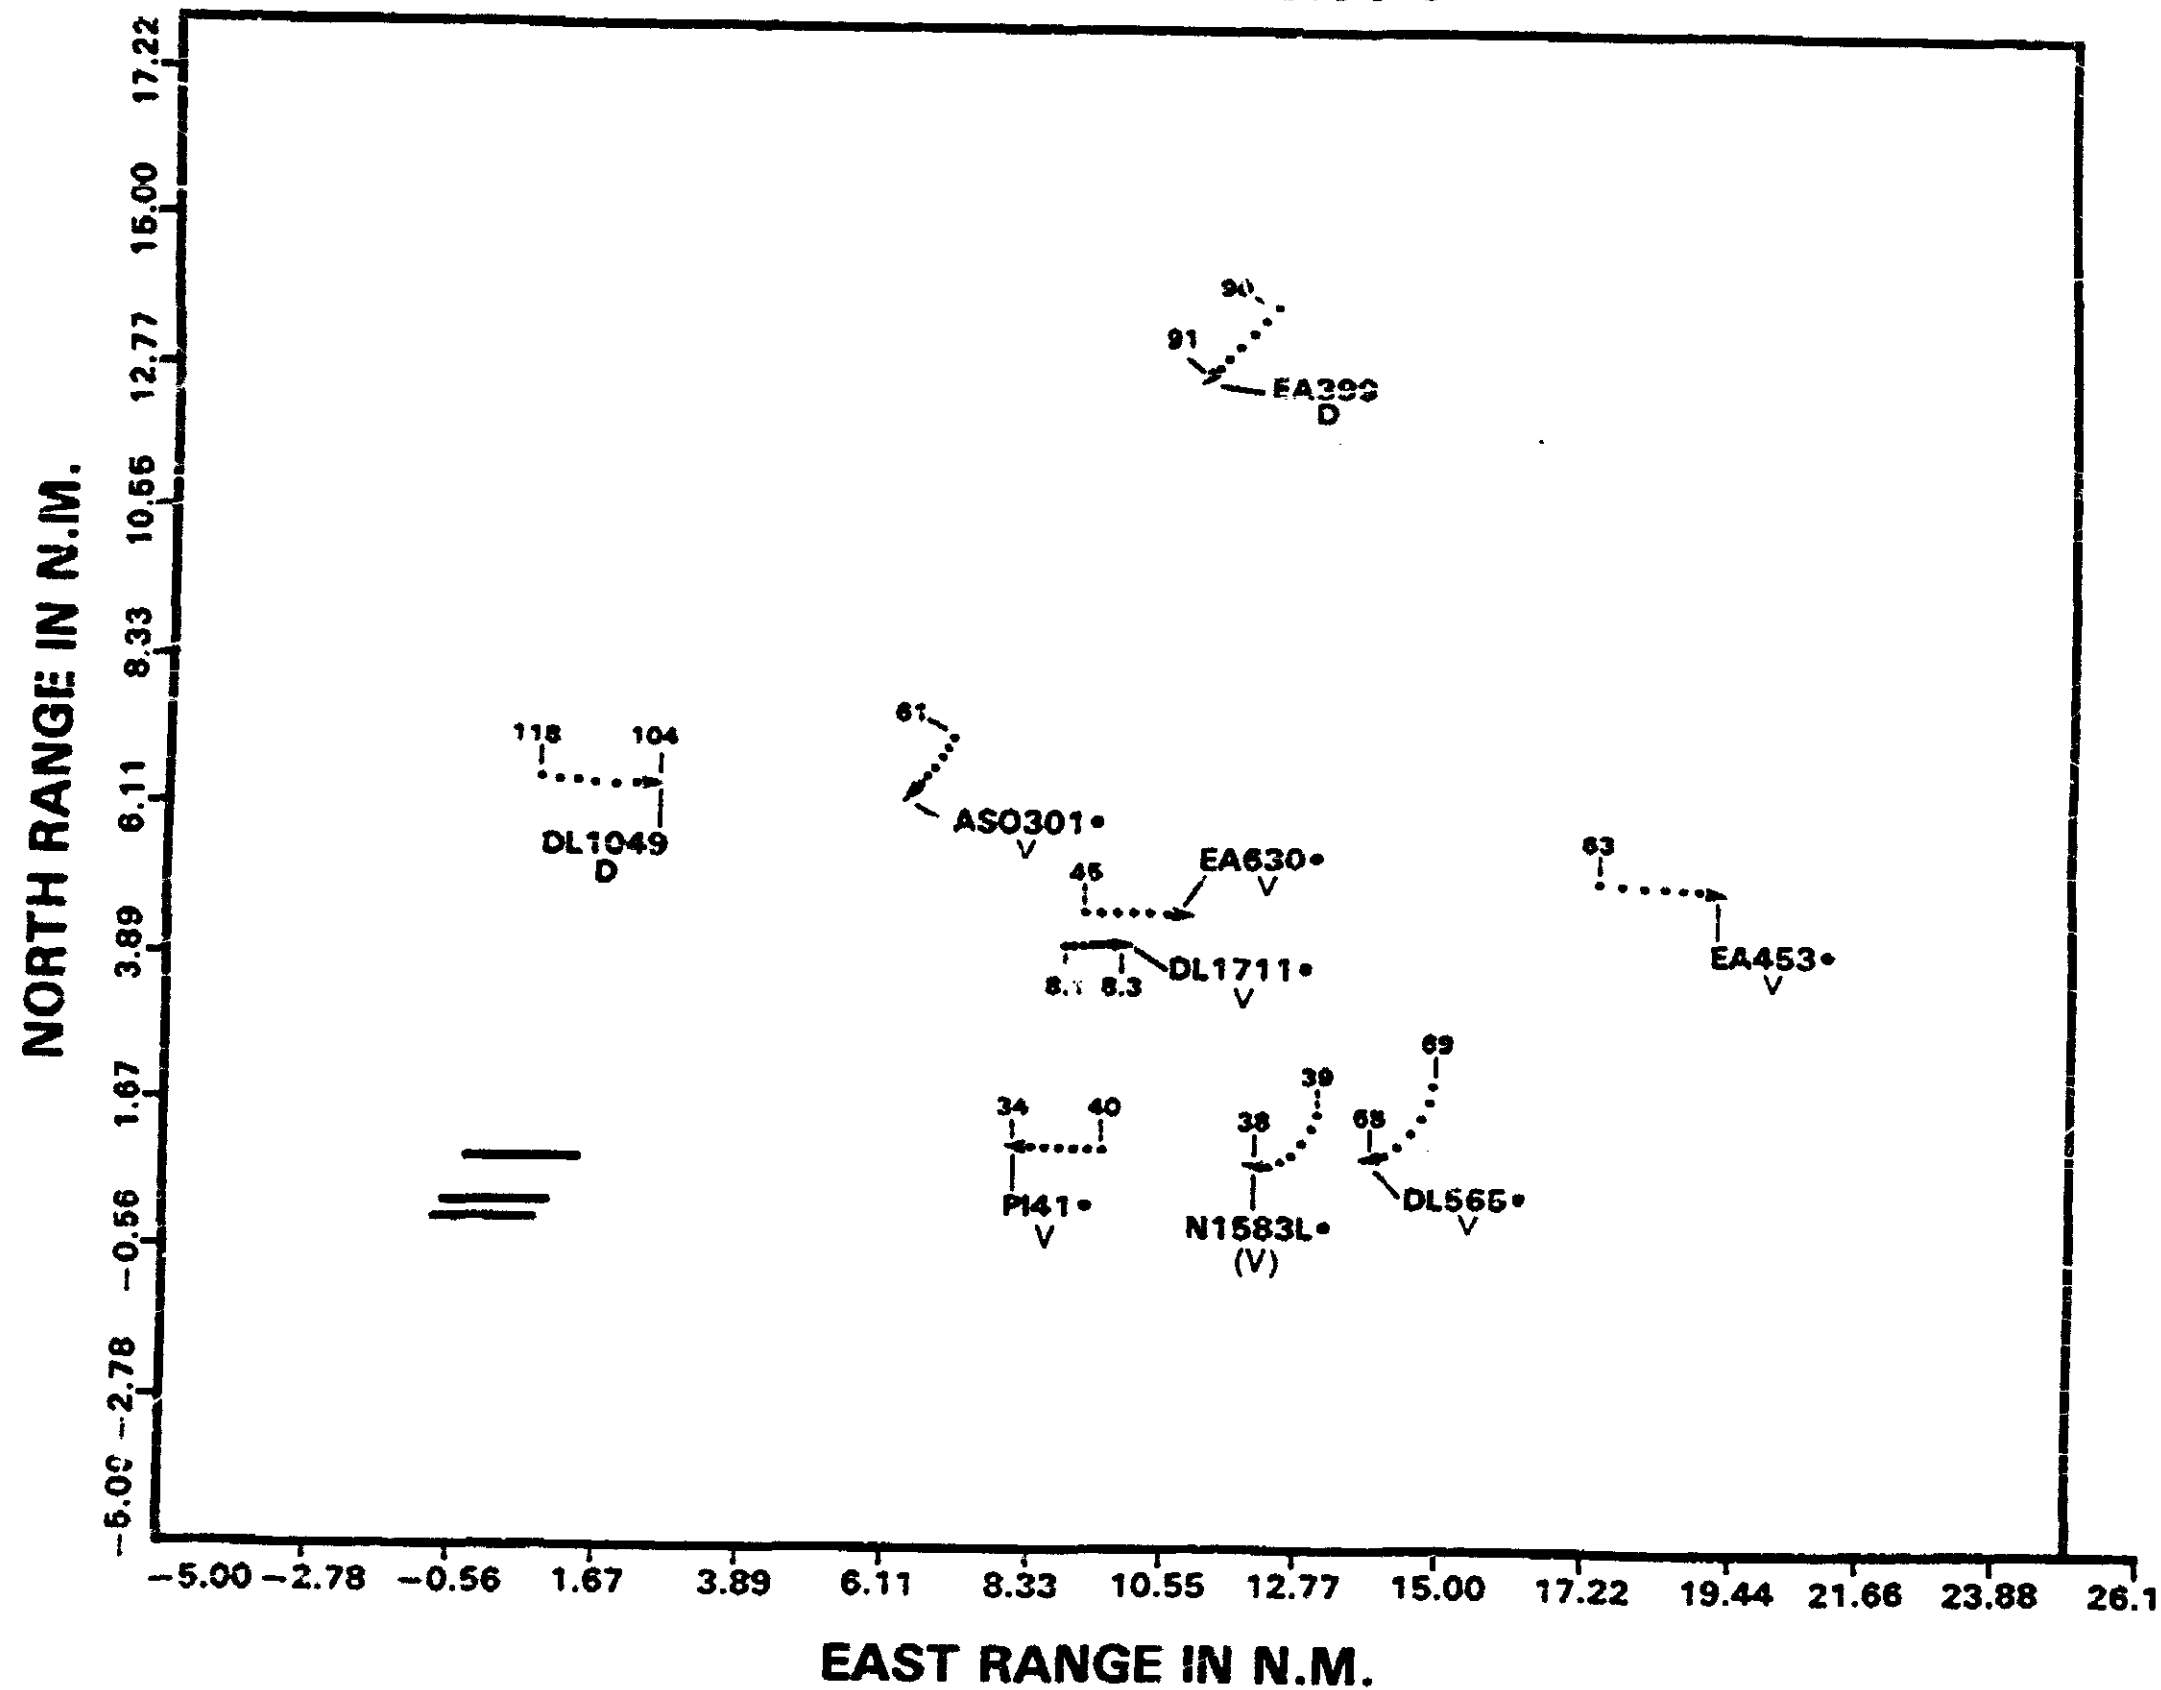
08:16:00.0-08:16:30.0

PI41 was not pointed out as preceding traffic before approach clearance was issued. The final controller is now extremely busy, and getting further behind. During the investigation the final controller said that at this point he was "too involved" to ask for help. Although he couldn't recall exactly when, he remembered hearing the supervisor "telling them not to put them on me." (Don't give any more aircraft to the final controller.)

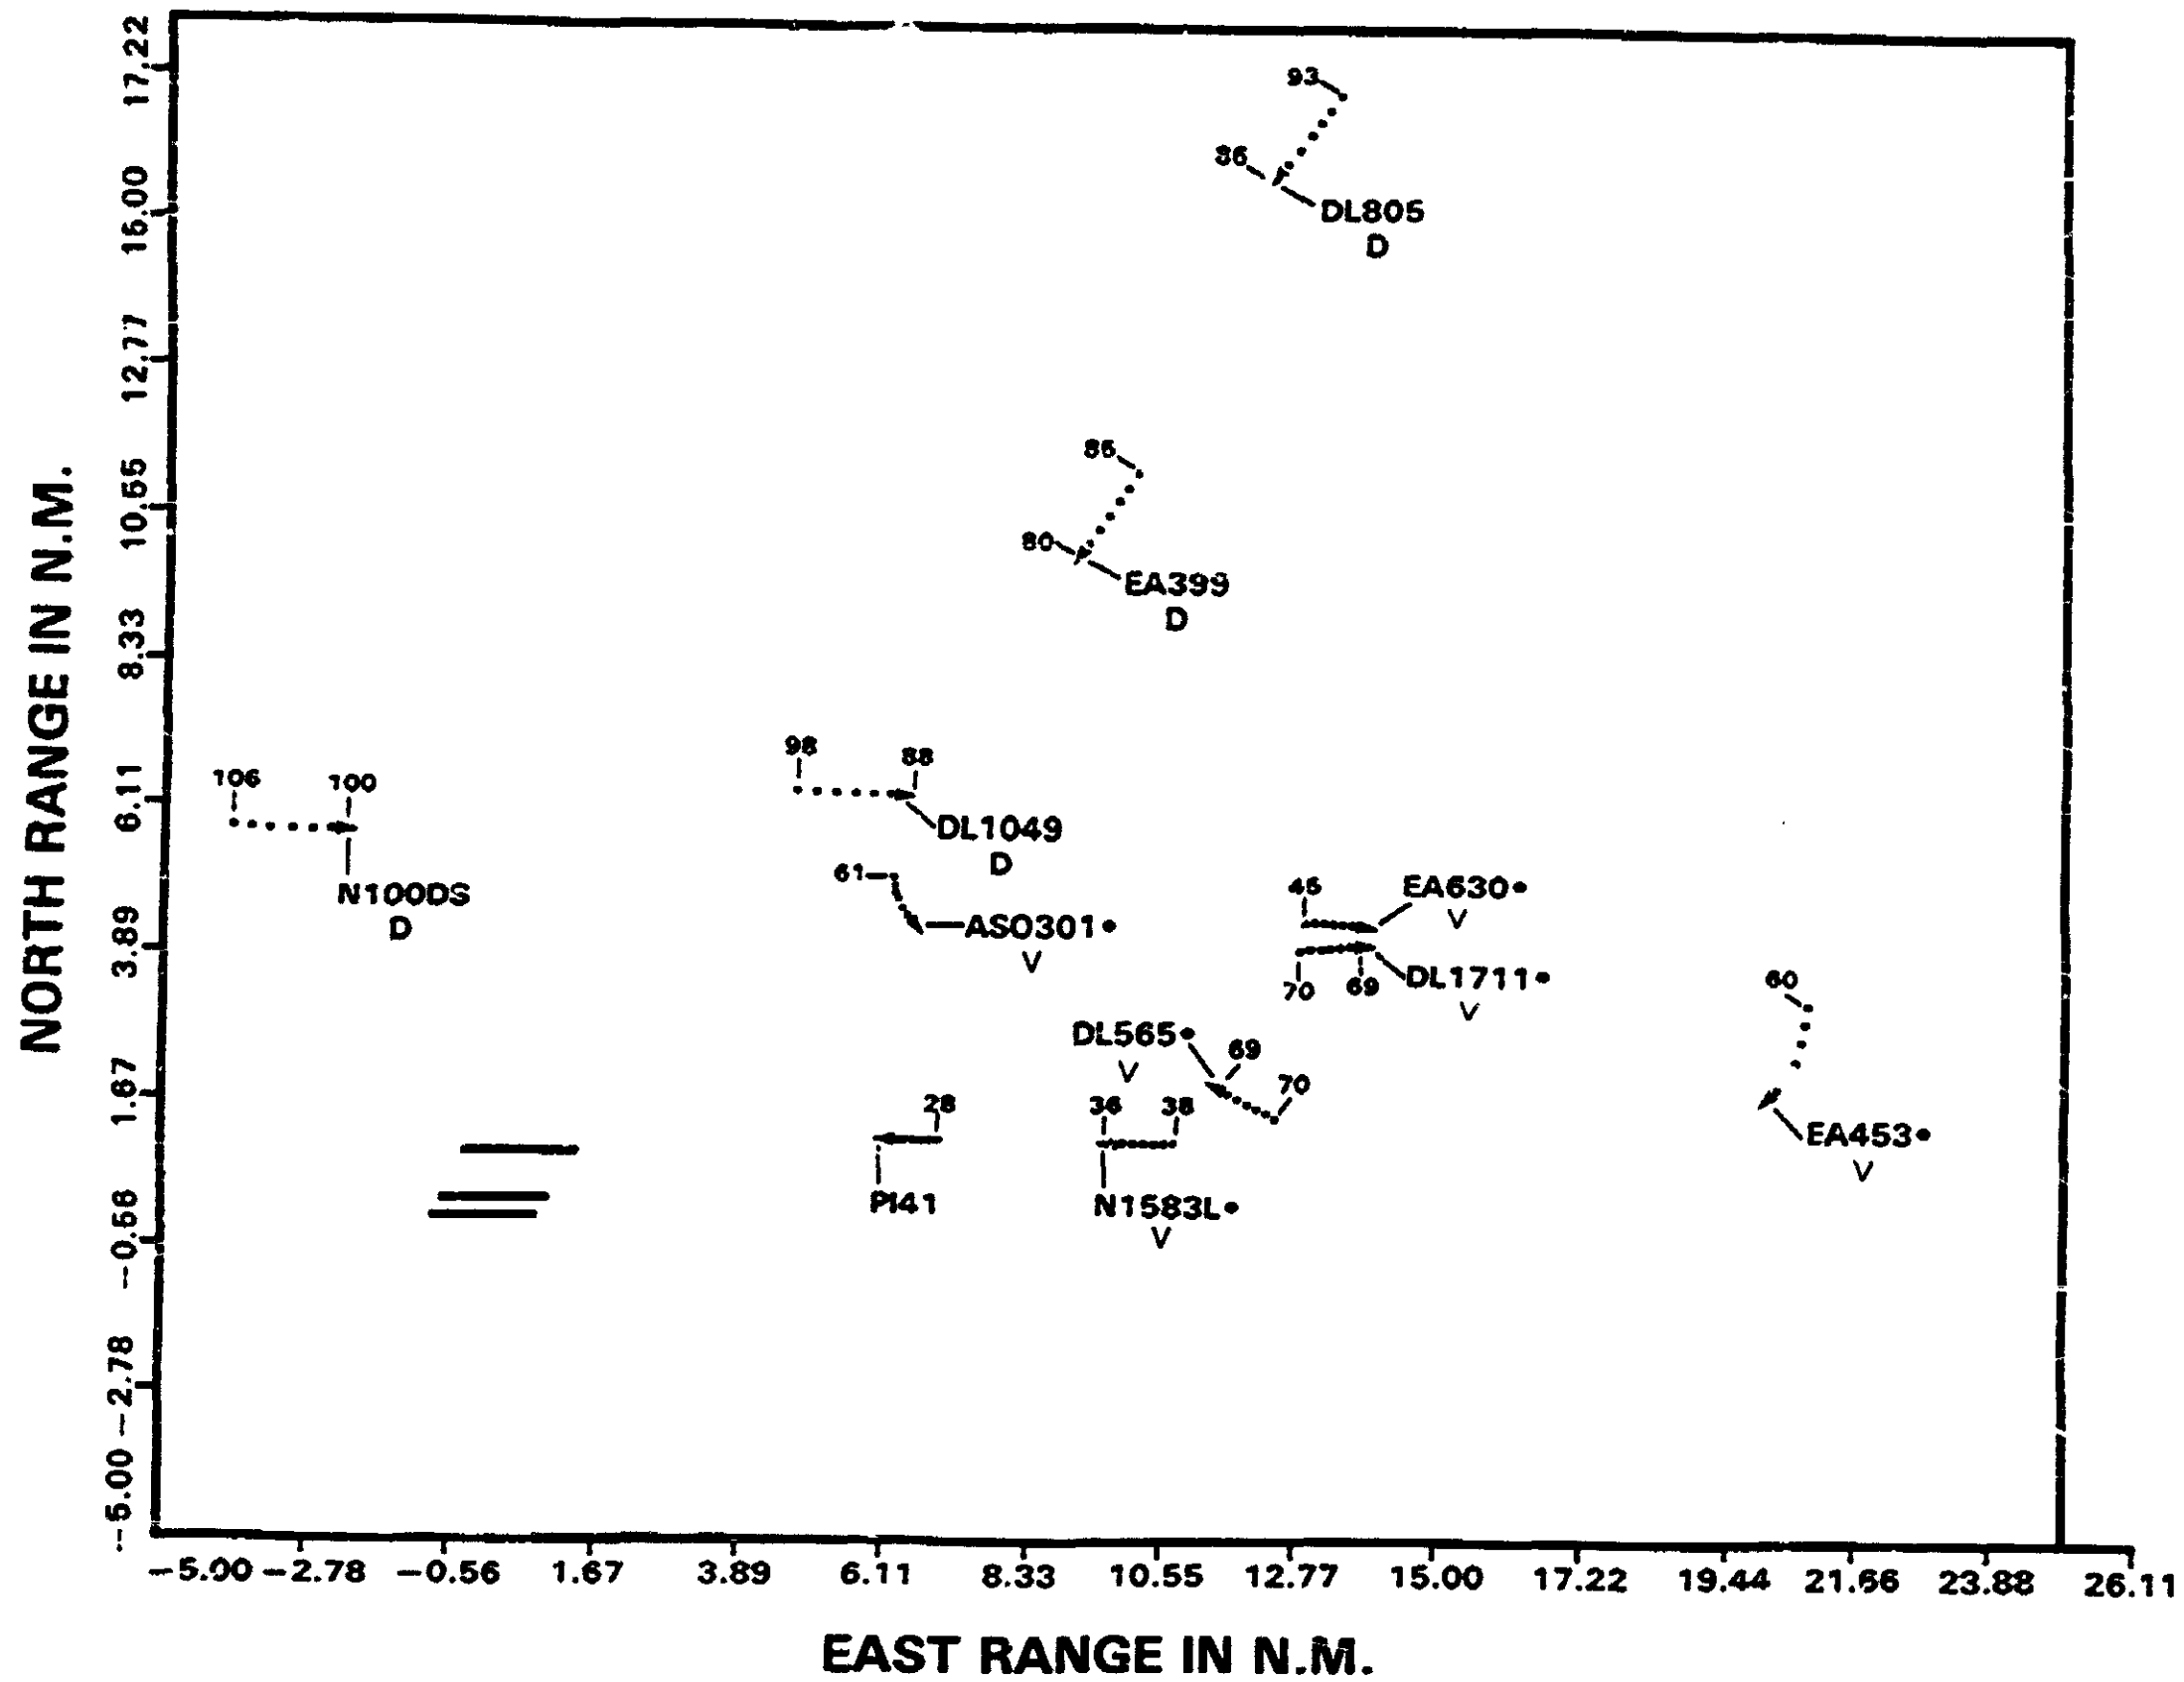
08:17:00.0-08:17:30.0

EA630 is now being put on a base leg. The apparent decision was that between EA453 and EA630, EA630 will be ahead. EA630 could have been placed behind EA453, especially since EA453 is now intercepting the localizer.

At 17:06.9 DL565 and DL1711 came within 2.55 nmi of each other. However, it should be noted that their courses are diverging and there was no conflict alert. Therefore, this is of relatively little importance.

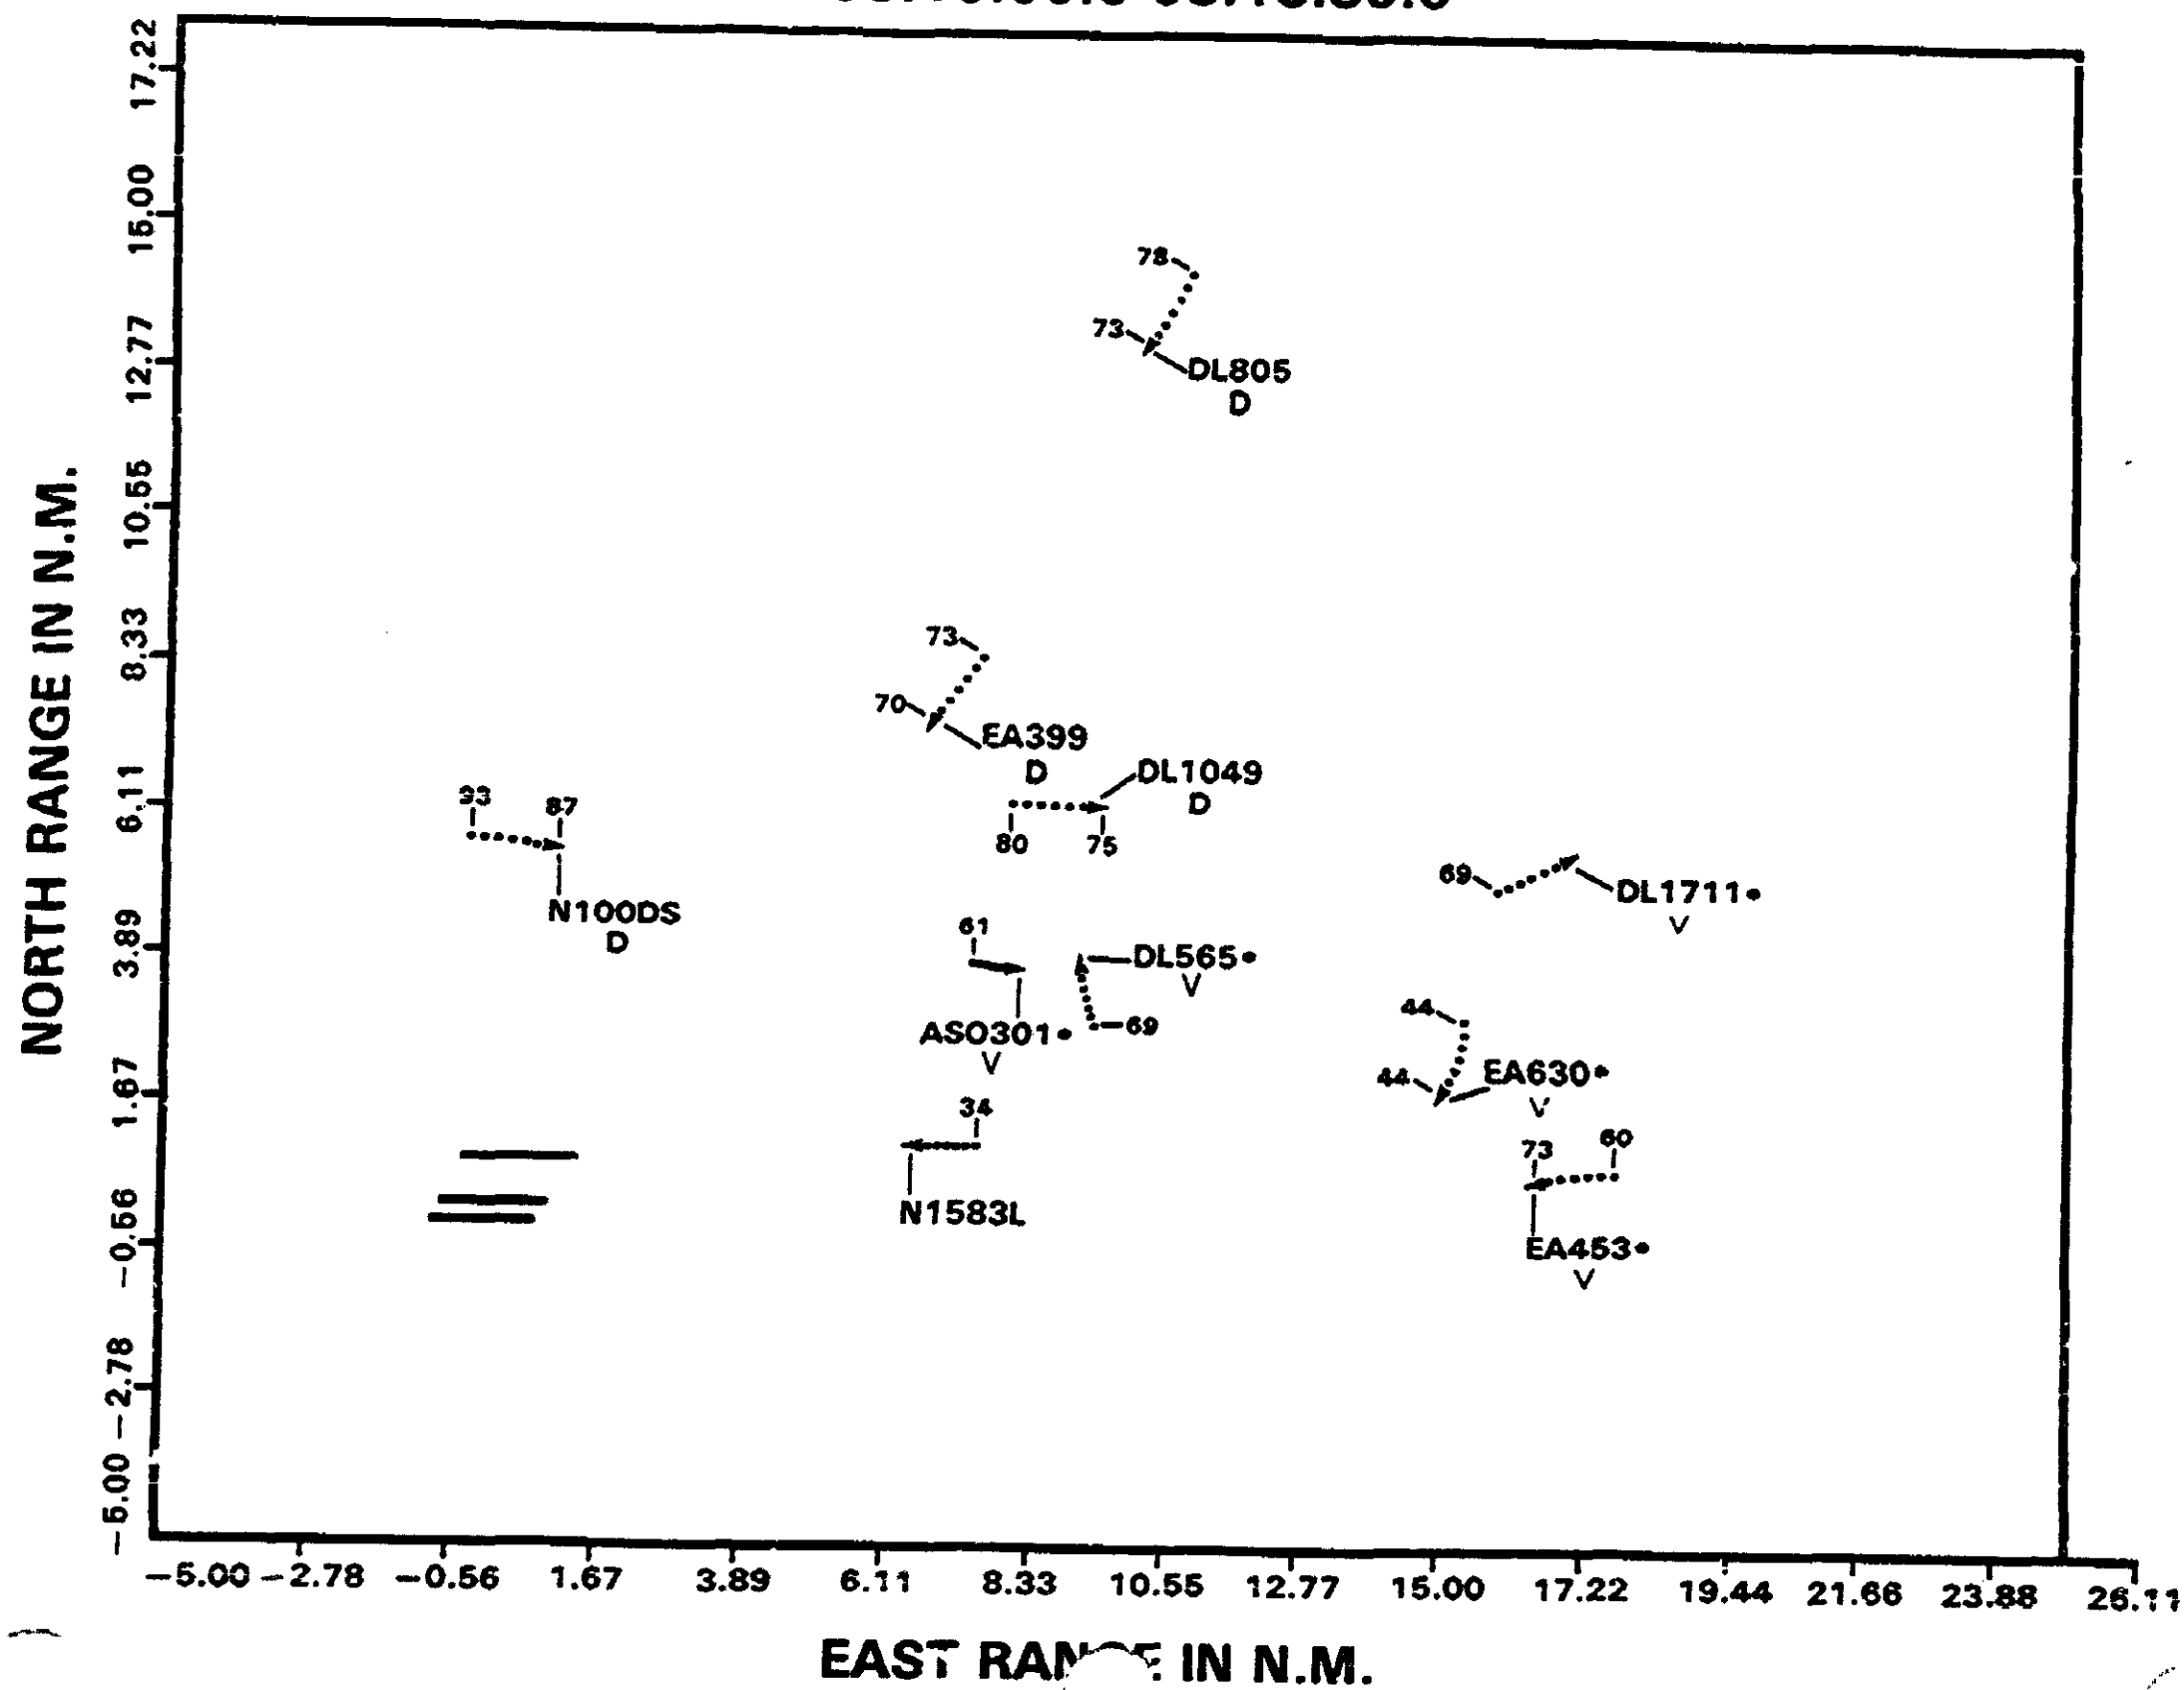
08:18:00.0-08:18:30.0

Noting the symbology of "D" and "V" which is depicted below the aircraft identification, DL1049, EA399, N100DS, and DL805 are under control of the feeder controller. At 0818:23 the feeder controller told EA399 to turn left to a heading of 090.

EA399 and DL1049 came within 500 ft and 2.16 nmi of each other. It should be noted however, that at this point their courses are diverging and there was no conflict alert.

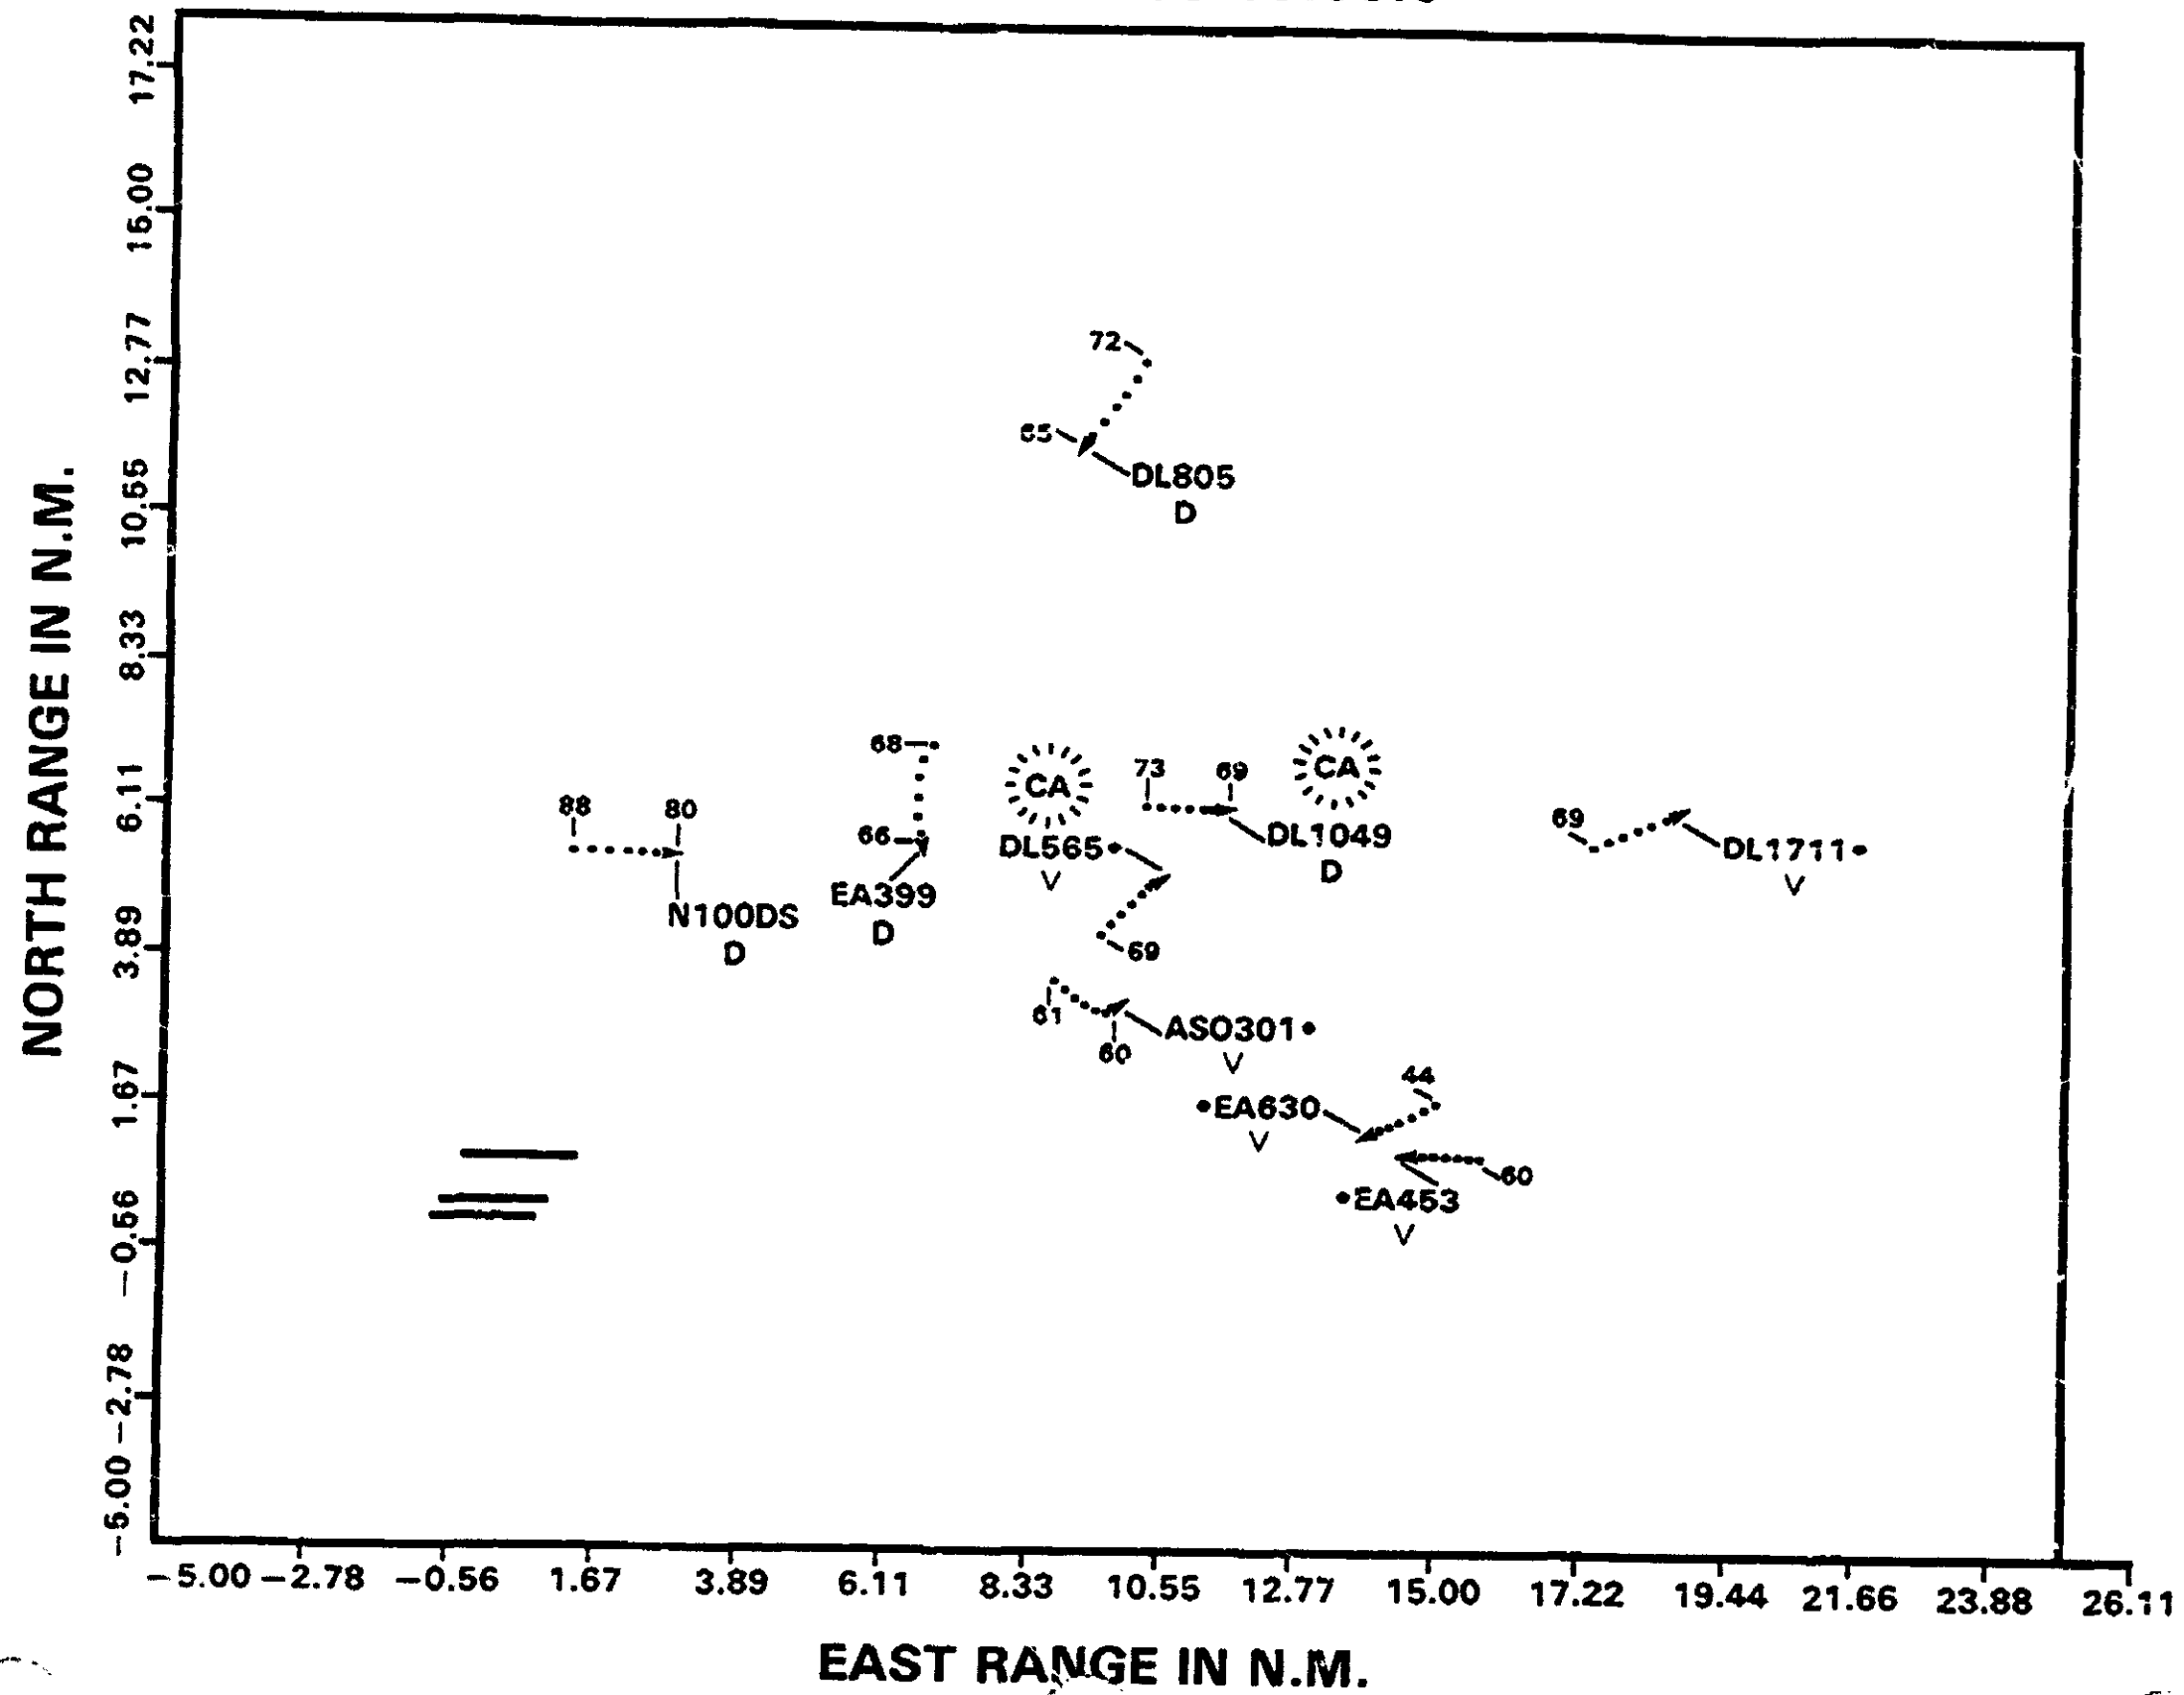
08:18:30.0-08:19:00.0

About the time that EA453 was issued the heading of 360, the conflict alert was activated for DL565 and DL1049. Delta 565 was then instructed to descend (correct action). At 08:19:17.9, the two aircraft came within 1.28 nmi and 500 ft of each other.
